## Expander® System secures district heating production in Linköping

# From pin bolt to permanent solution with Expander®System

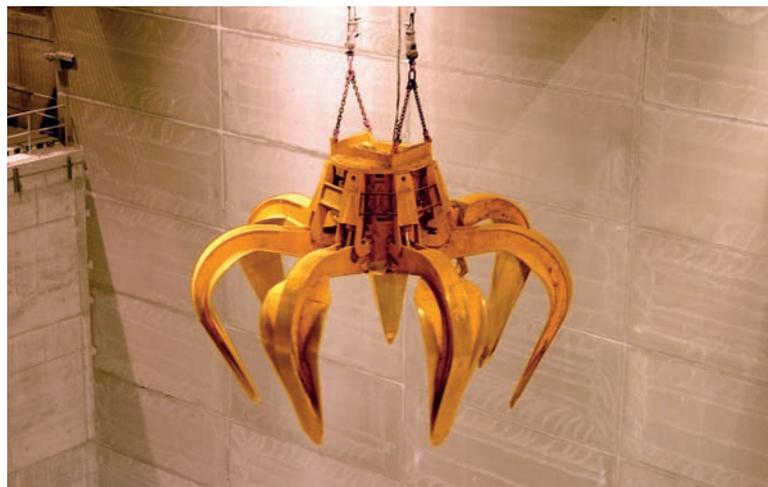
**New stable design solution.**

The original pivot consisted of a pin bolt design through the "crown" to the arm's two outer mounting lugs. The bolt was fixed at the centre and the arm moved over the outer ends of the fixed shaft, carried on bronze bushings. Expander suggested another solution. A traditional box construction, with stable mountings in the arm's outer lugs – and instead pivoted by an Expander bolt with a hardened steel bushing at the centre section. – We purchased the solution, Olle says, despite the greater cost of the design. But we saw it as a "one off cost" – and something radical was required anyway. For safety's sake, while the grab was disassembled, we also changed the hydraulic pivots to Expander.

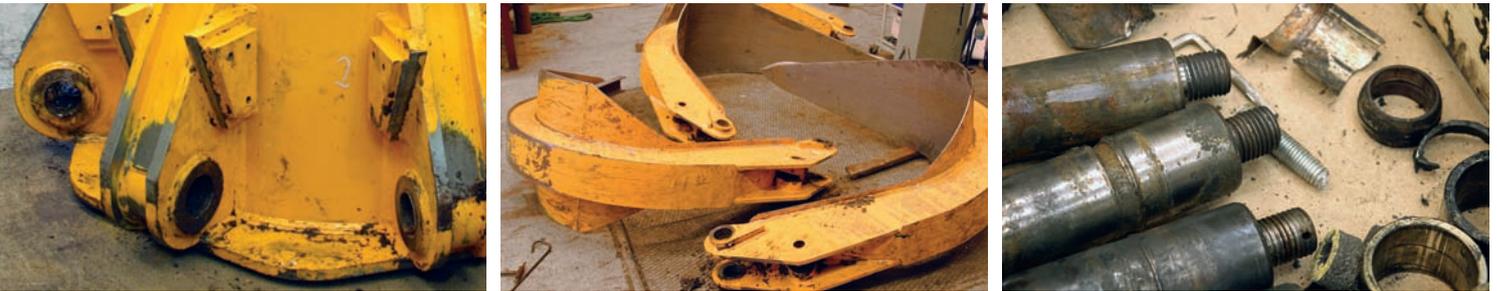
Part of the crown without the arms. Note the deformation of the materials and remains of the damaged mounting.

Removed arms. The mounting lugs must be cleaned but need not be rebored – the Expander system takes up the deformation and unevenness.

Damaged pin bolts and remains of worn bronze bushings – Cause of both seized pivots and blocked lubrication channels.

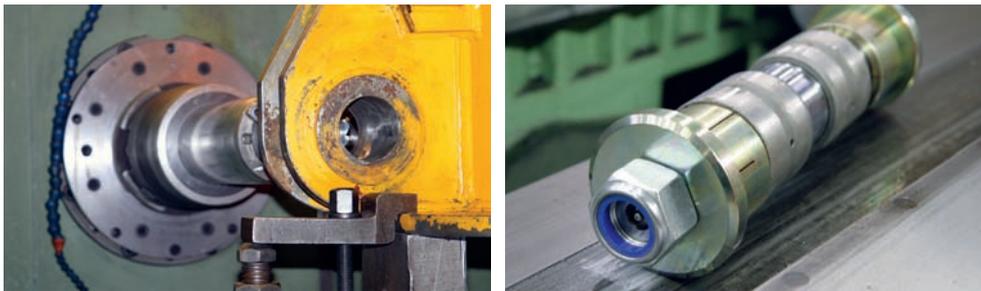
One of the seven centre sections is bored out, from 75 to 85 mm in diameter, to provide space for the Expander bolt and the hardened steel bushings.

The Expander system with the double hardened steel bushings. Note the slotted, conical sleeves on the outer ends, which take up unevenness and provide stable locking in the respective mounting lugs.

The renovated crown; a permanent solution with a 10 year function warranty!
