# Permanent solution to pivot wear with **Expander bolt**

**As smart as it is simple, the Expander bolt system provides a highly cost-effective solution to the problem of wear in mechanical pivots and mounts**

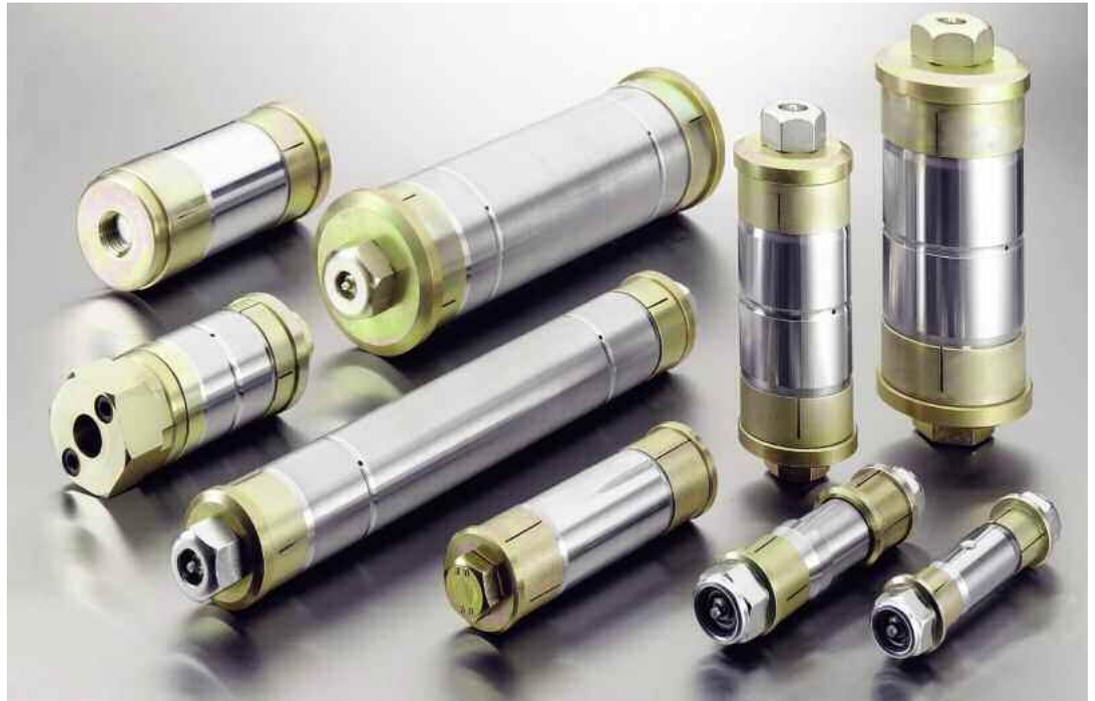
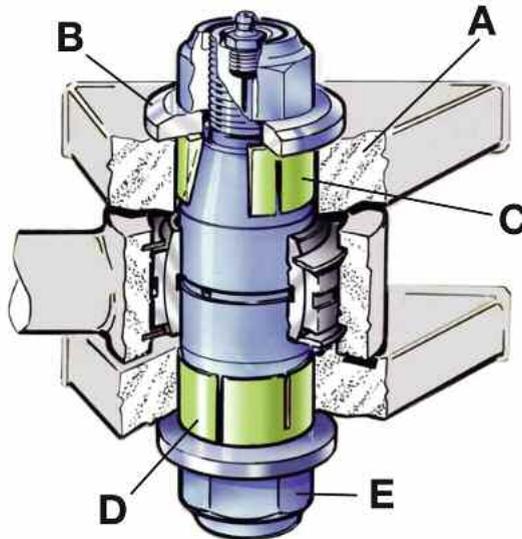
**How it works: (A) Expander System is installed directly into the existing mounting without expensive welding or line boring. (B) The washer presses the sleeve onto the tapered section of the expander bolt. (C) The sleeve expands in the worn lugholes in parallel and eliminates all play. (D) Double sided locking gives increased safety. (E) The system is easy to remove and reinstall.**

In use, two expanding sleeves fill the gap and connect the attaching eyes. While conventional pivot pins are only locked on one side, the Expander system locks on both sides. This gives a stronger box construction to the whole machine pivot. The sleeves expand over both ends of the tapered axle and lock securely even if the hole is worn. If the hole has worn oval the Expander system fills out the ovality and gives a secure solution without any preparatory machining.
